Nurse Tank Rupture, June 06, 2005

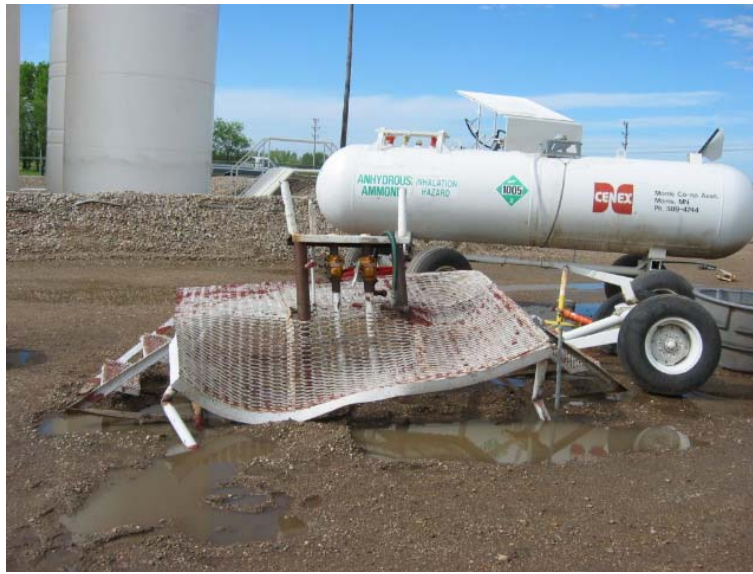
Initial location of the 1,000 gallon nurse tank. A similar tank is shown in the background.

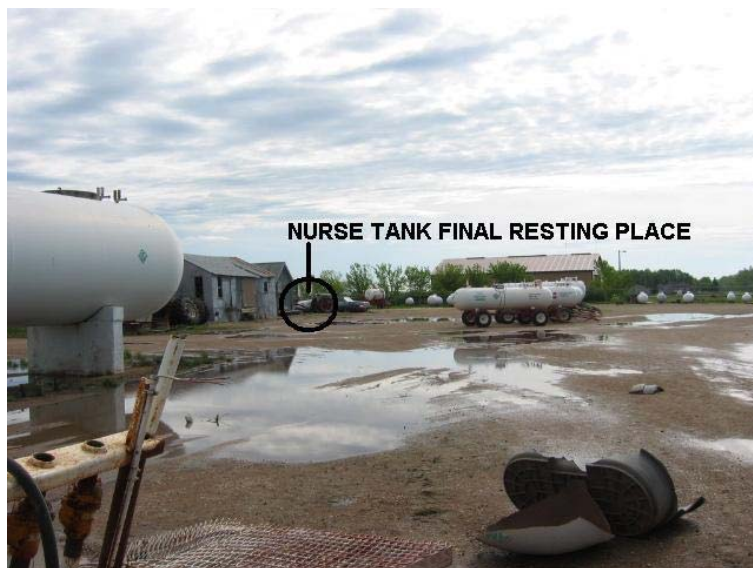
Final resting place of the nurse tank approximately 250 feet away. Part of the tank shell is located in the lower right portion of the photograph.

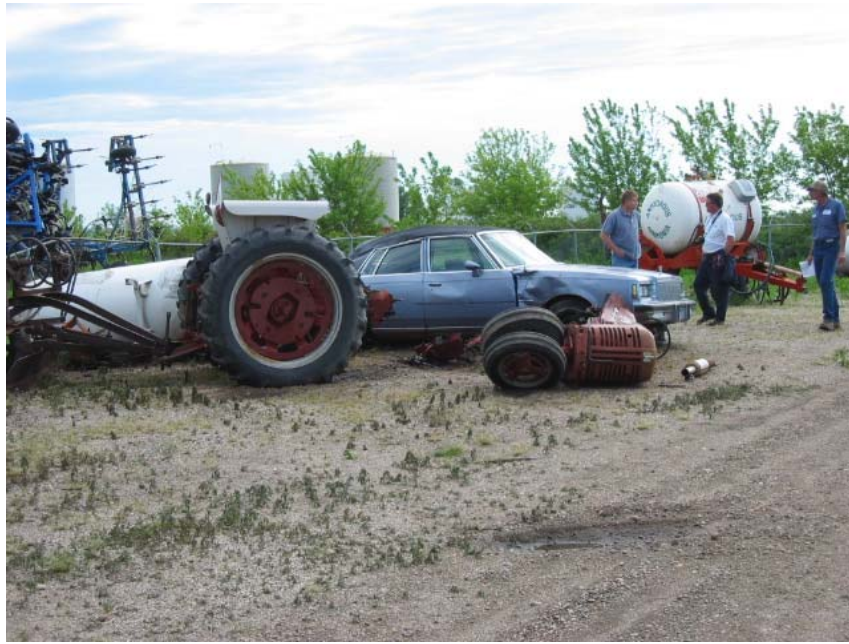
Tank split apart this tractor before finally coming to rest on its side.

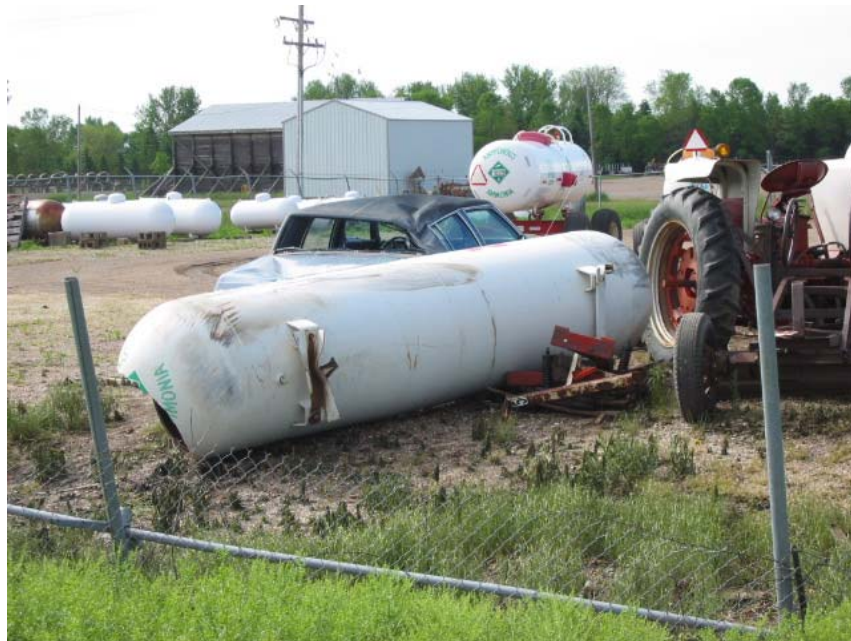
Running gear absent. Gear remained at load-out risers.

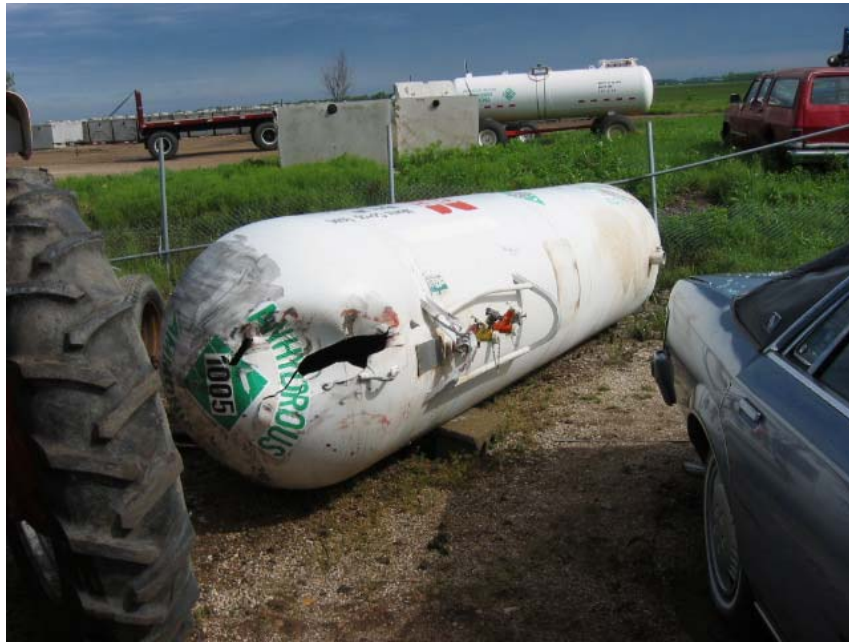
Front of nurse tank showing black rubber tire marks and red paint from when the tank struck the tractor. Dent and opening also caused by collision.

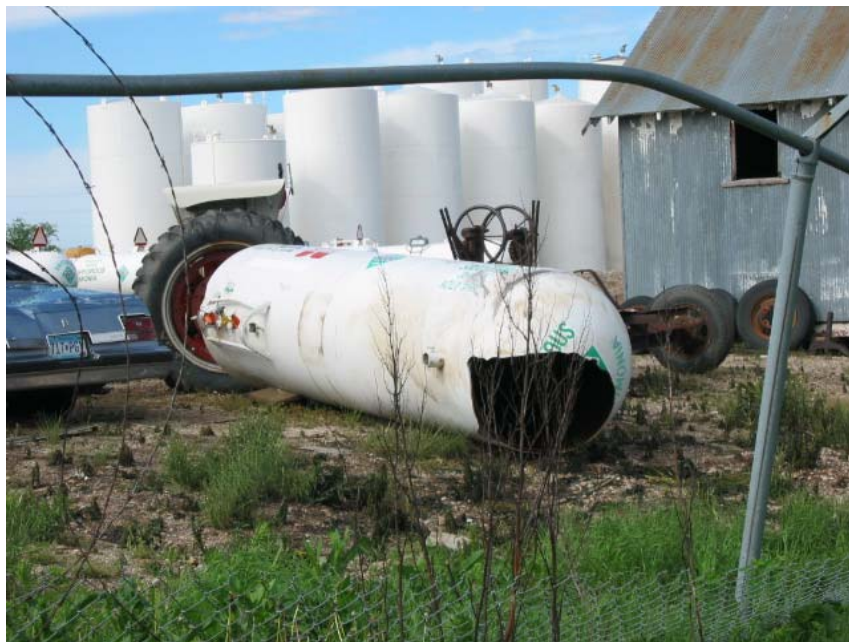
An internal non-code weld had weakened the shell of an anhydrous ammonia nurse tank causing the tank to rupture. The full, pressurized tank (125 psi) was propelled across the facility yard narrowly missing bulk agricultural chemical tanks and buildings as it flew. The tank came to rest approximately 250 feet away after first splitting a tractor in half. An extensive cloud of ammonia vapor drifted away from all major populated areas although some nearby residents were treated for exposure. This tank was manufactured in 1973.

Large opening where the tank failed. Absent shell piece remained by load out risers.

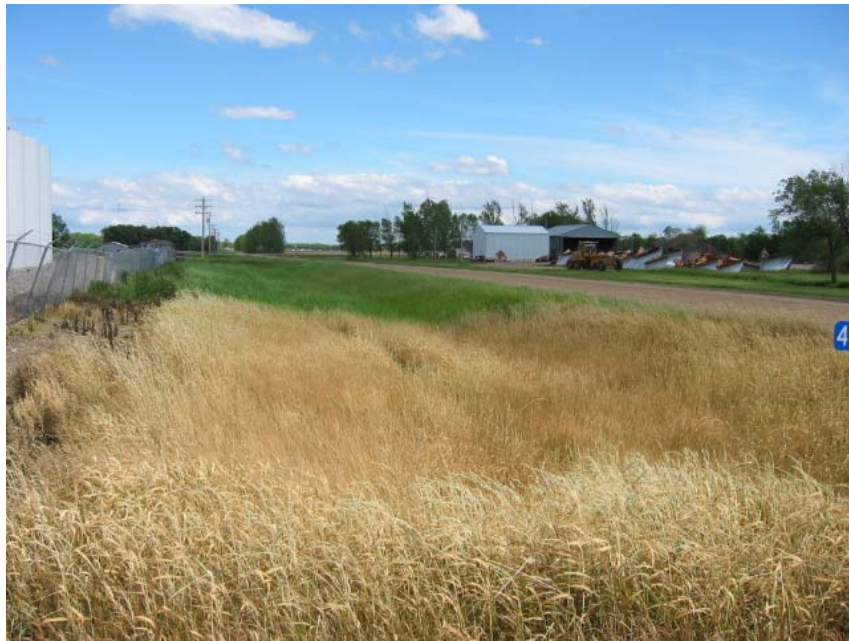
Ammonia cloud drifted over this ditch causing grass leaf burn.

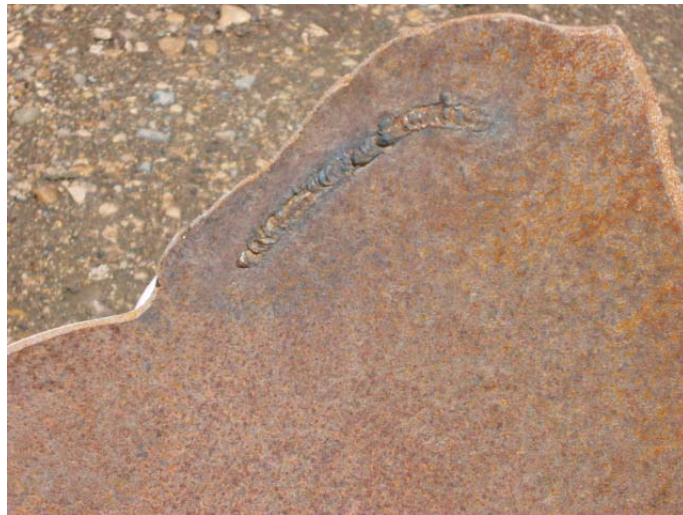
A weakened tank shell around this weld was the likely cause of the nurse tank rupture.
