Nurse Tank Rupture, June 06, 2005

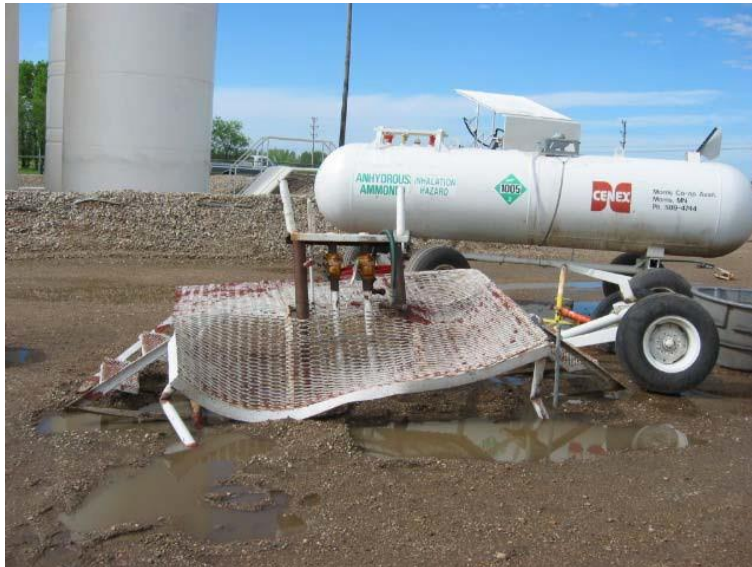
Initial location of the 1,000-gallon nurse tank. A similar tank is shown in the background.

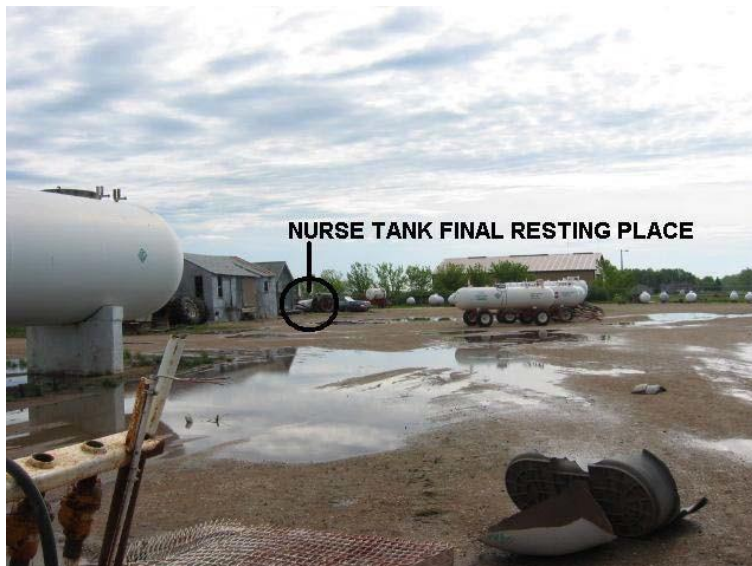
Final resting place of the nurse tank approximately 250 feet away. Part of the tank shell is located in the lower right portion of the photograph.

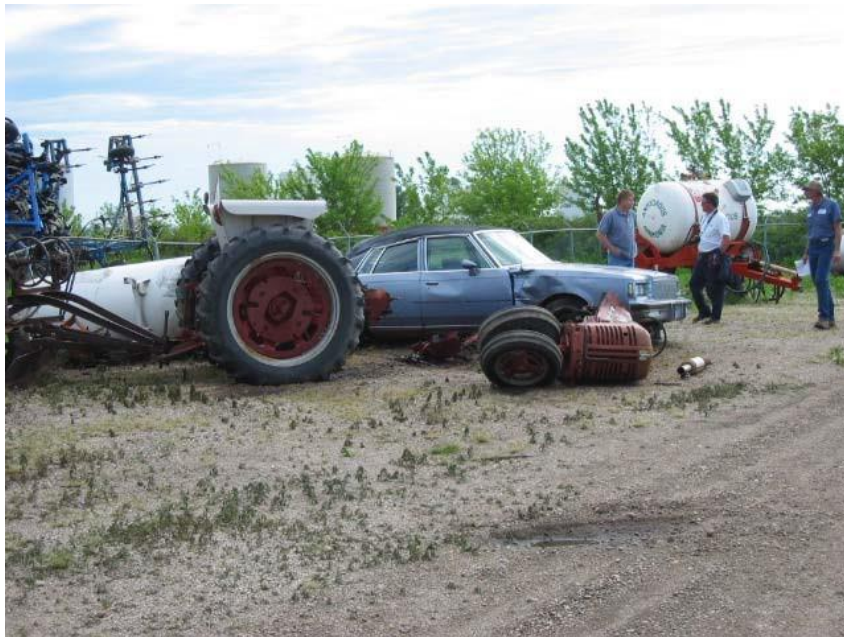
Tank split apart this tractor before finally coming to rest on its side.

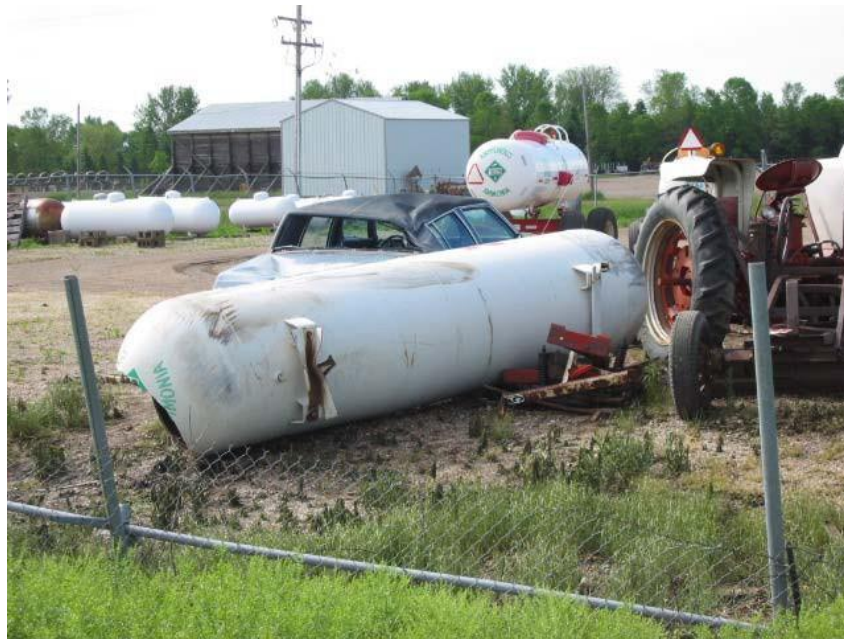
Running gear absent. Gear remained at load-out risers.

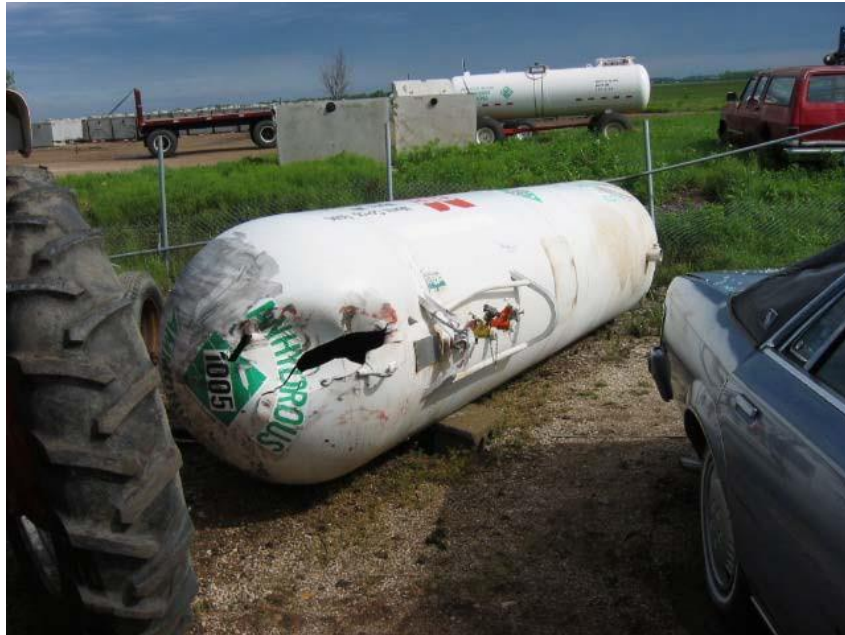
Front of nurse tank showing black rubber tire marks and red paint from when the tank struck the tractor. Dent and opening also caused by collision.

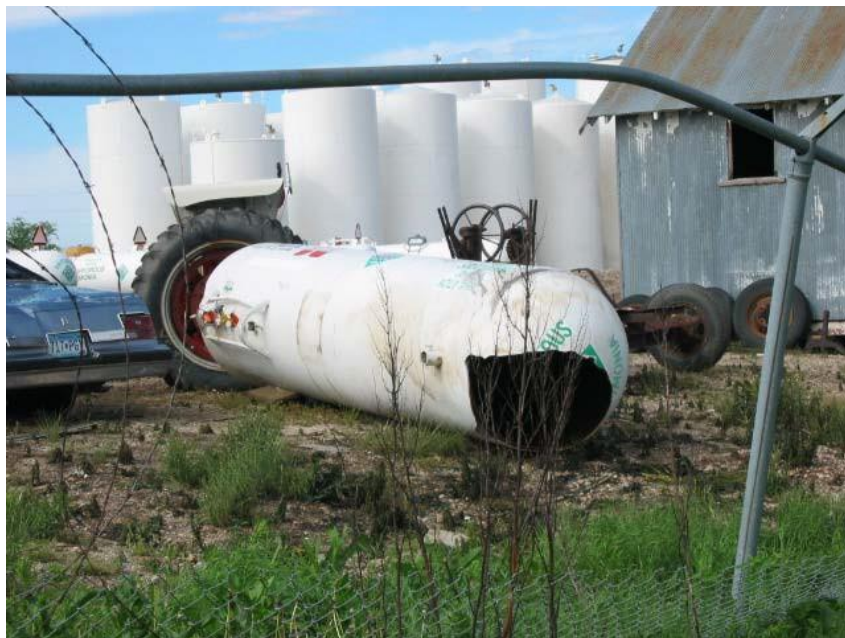
An internal non-code weld had weakened the shell of an anhydrous ammonia nurse tank causing the tank to rupture. The full, pressurized tank (125 psi) was propelled across the facility yard narrowly missing bulk agricultural chemical tanks and buildings as it flew. The tank came to rest approximately 250 feet away after first splitting a tractor in half. An extensive cloud of ammonia vapor drifted away from all major populated areas although some nearby residents were treated for exposure. This tank was manufactured in 1973.

Large opening where the tank failed. Absent shell piece remained by load out risers.

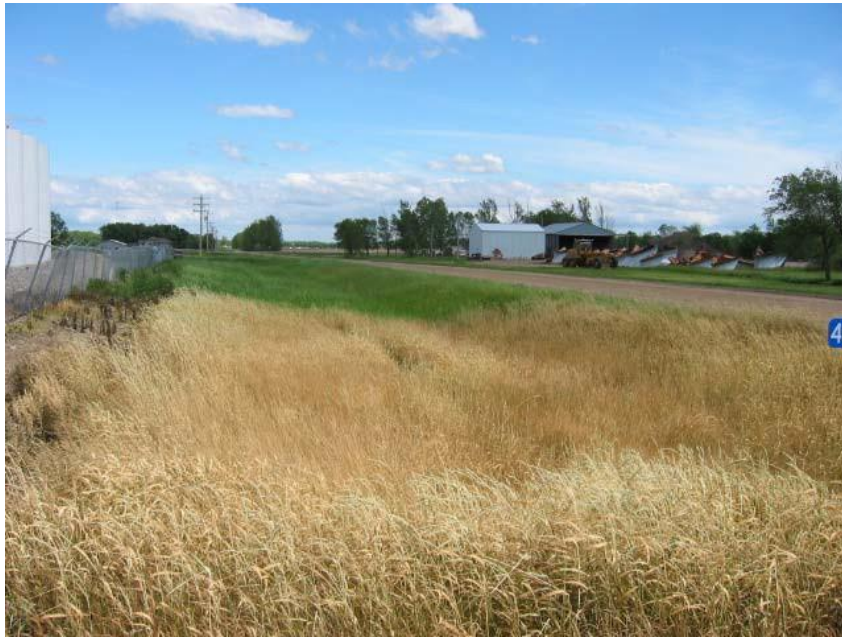
Ammonia cloud drifted over this ditch causing grass leaf burn.

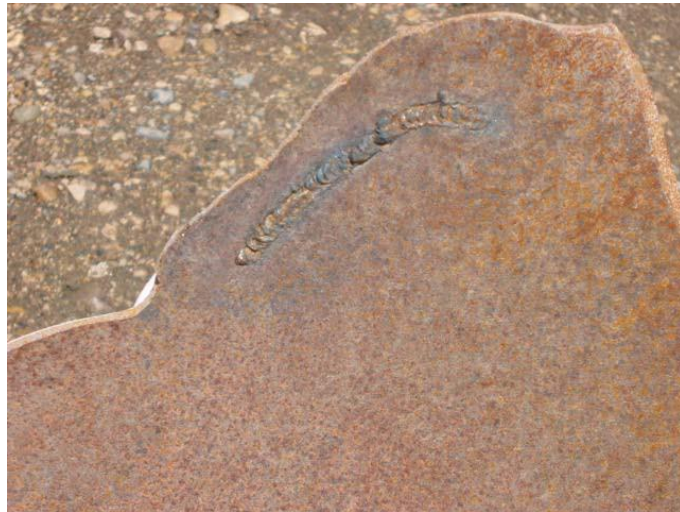
A weakened tank shell around this weld was the likely cause of the nurse tank rupture.
